# Case Study

## Full Depth Slab Replacement Gilroy, CA September 18, 2008

**Location:** US 101 Southbound, Lane 4, Cochrane Exit, Gilroy, CA

**Purpose:** Replace existing shattered slab using CERATECH's Non Portland, Ultra GREEN **GreatWhite**® rapid volumetric cement as a beta test to determine suitability and long term durability for CALTRANS

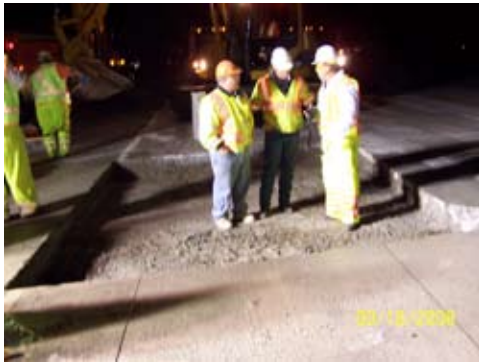
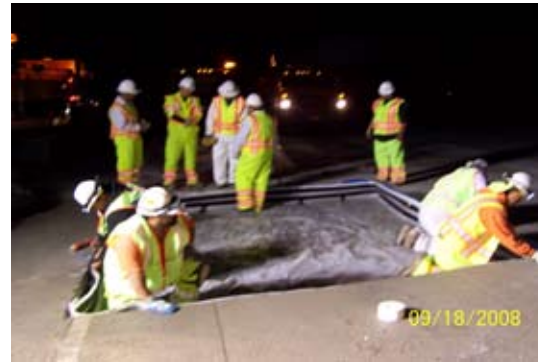
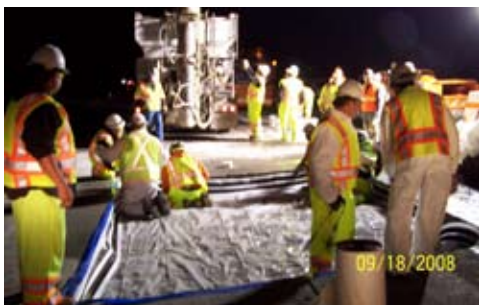
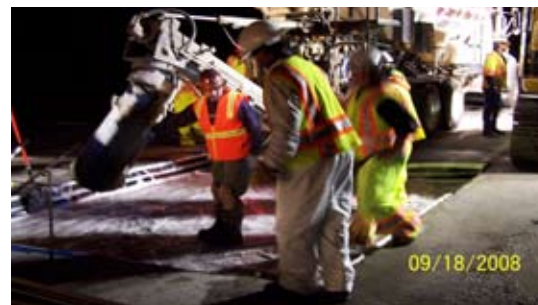
On the evening of 18 September, CALTRANS replaced an existing shattered and settled slab on US 101 freeway using **GreatWhite**®. The purpose of this placement was for CALTRANS officials to evaluate CERATECH's ultra green, GreatWhite™ rapid cement as a high performance repair material. CALTRANS currently subcontracts slab replacement work and is considering performing it themselves, so this was a training and evaluation evolution of the CALTRANS crew as well. This was also the first heavy traffic application for CERATECH's **GreatWhite**® rapid cement.

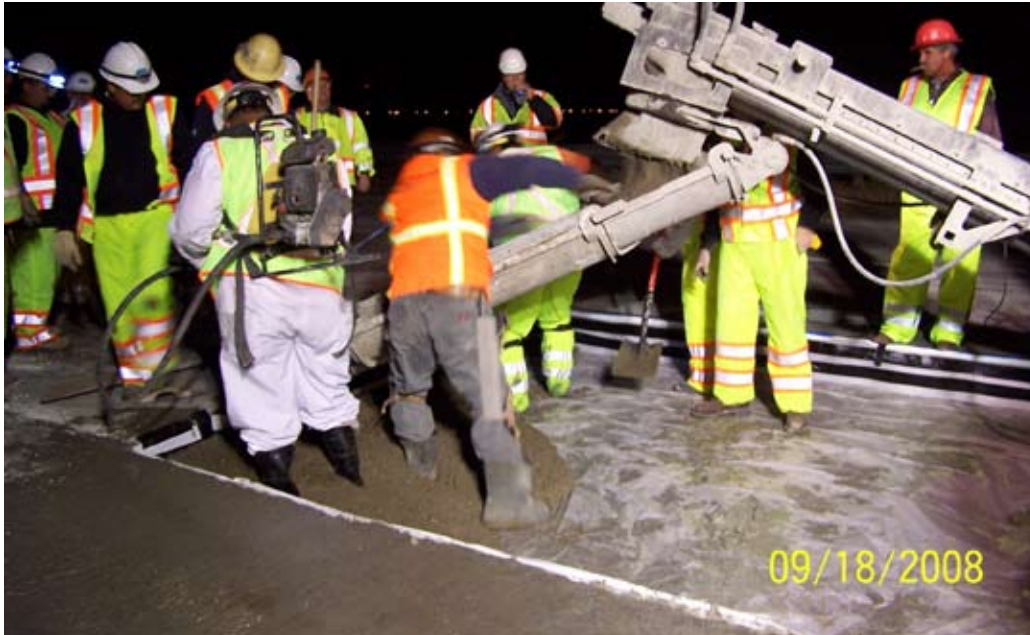
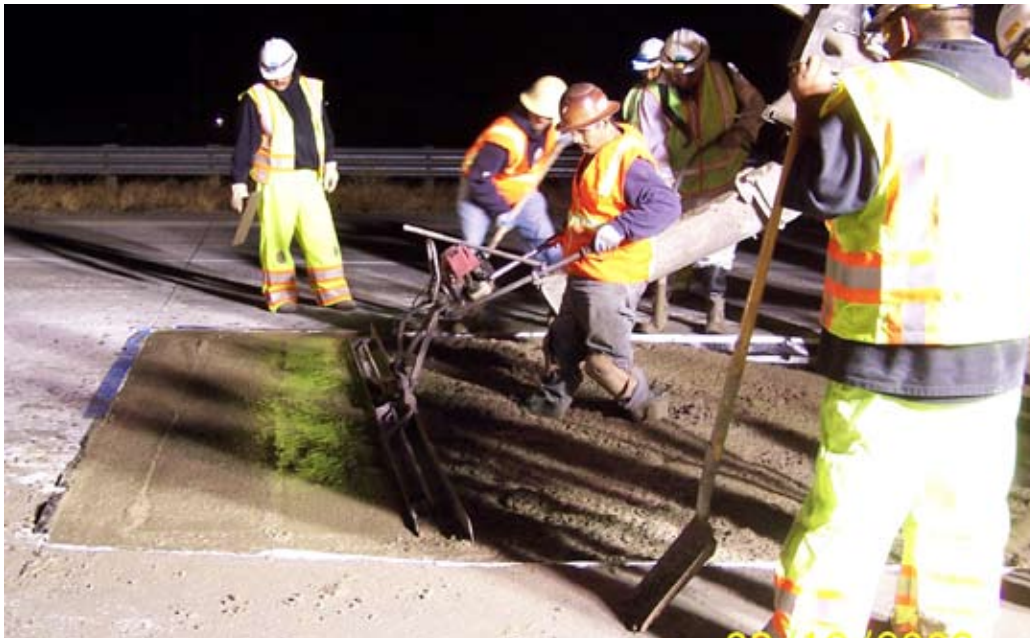
Weather for 18 September was overcast with a light breeze from 3-5 mph. Ambient temperatures during placement were around 55°F-60°F. Material and water temperatures reflected the ambient conditions.

A 10 cuyd Global volumetric mixer equipped with a 9” diameter mixing auger was used for this project. In order to support this application, we added an additional high flow admix system to introduce CERATECHS liquid activator admixture at the required dosage rate. A color admix system was re-purposed to introduce the SRA.

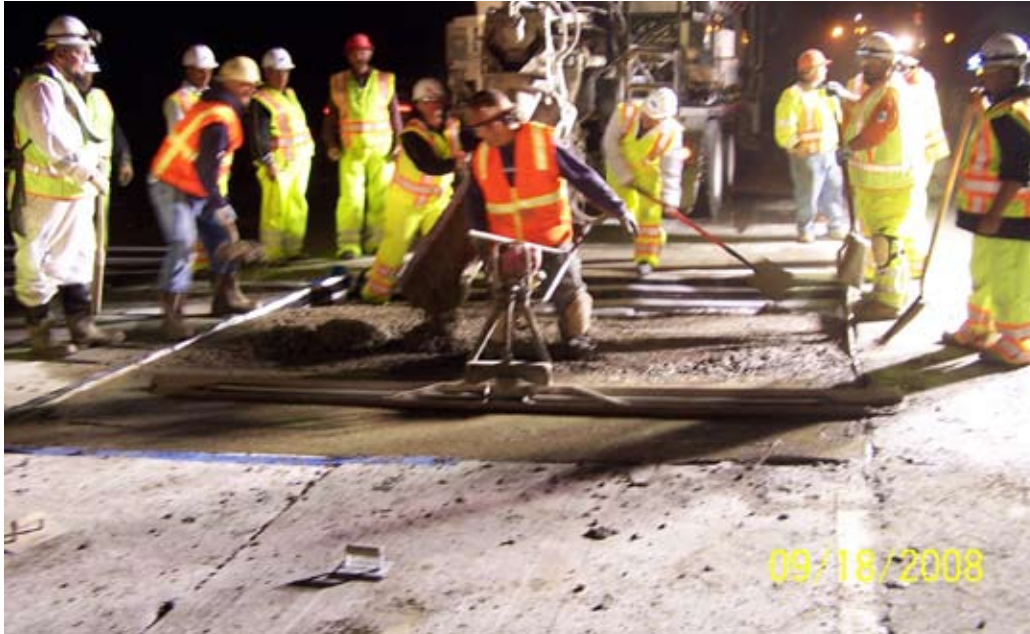
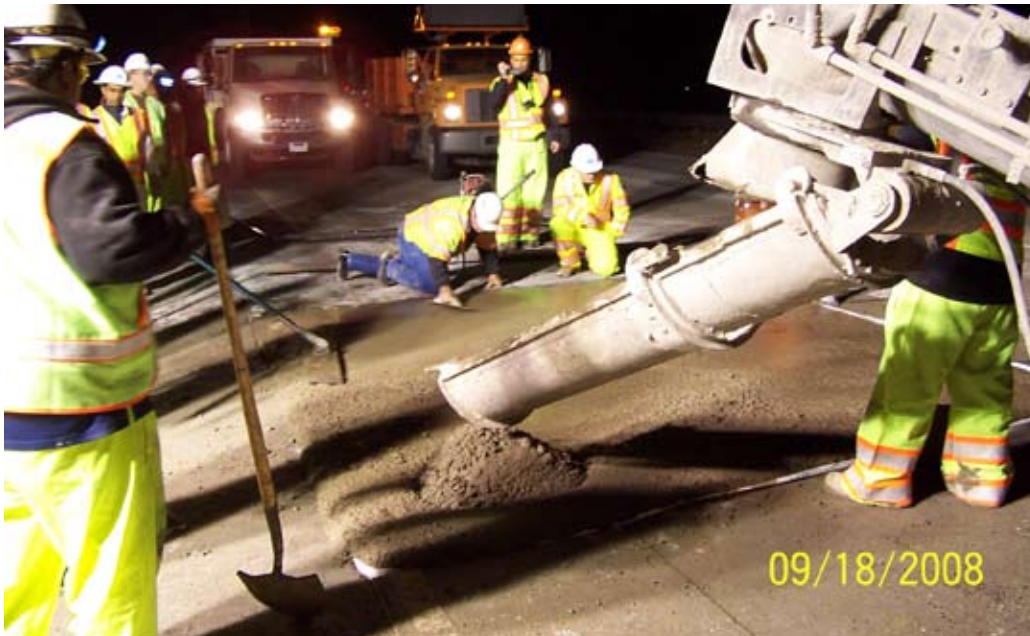
2:00 AM - In order to facilitate a full slab replacement, 2 lanes were required to be closed. A quick examination of the slab while the crew saw cut the perimeter revealed that a 12'x15' slab was shattered, by definition, due primarily to settlement of the base courses. Transverse joints were skewed by ~15°, with both transverse and longitudinal joints being dowelled. After sectioning and removing the debris, slab thickness from surface varied from 9" to 11".

Foam was attached to the perimeter of the existing pavement to isolate the new slab. 6 mil plastic sheeting was laid over the base after the water from sawcutting drained away to prevent interlock. The new slab would not be dowelled into the existing pavement.

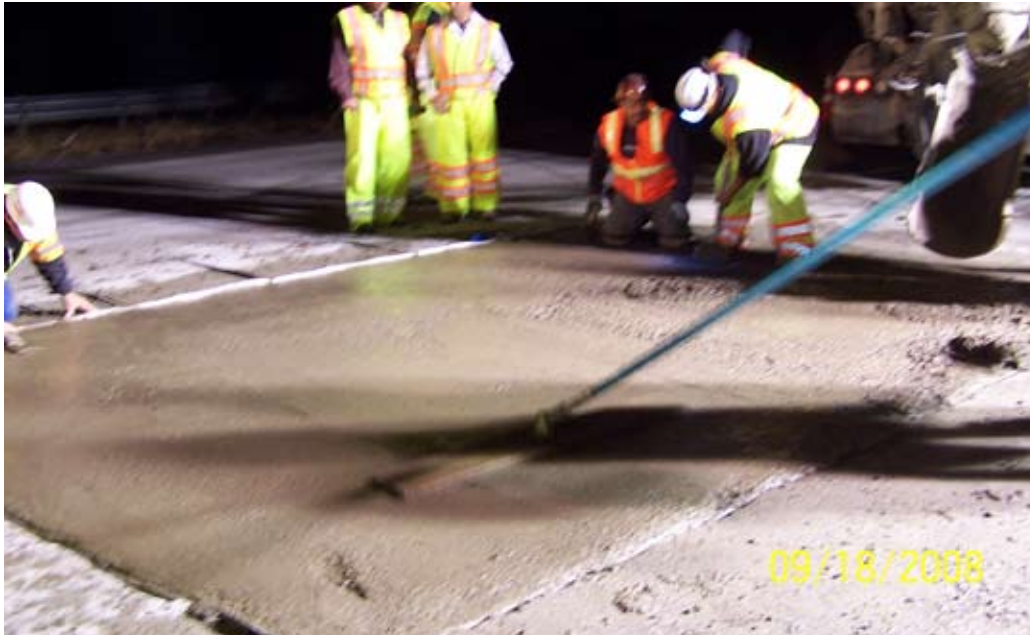
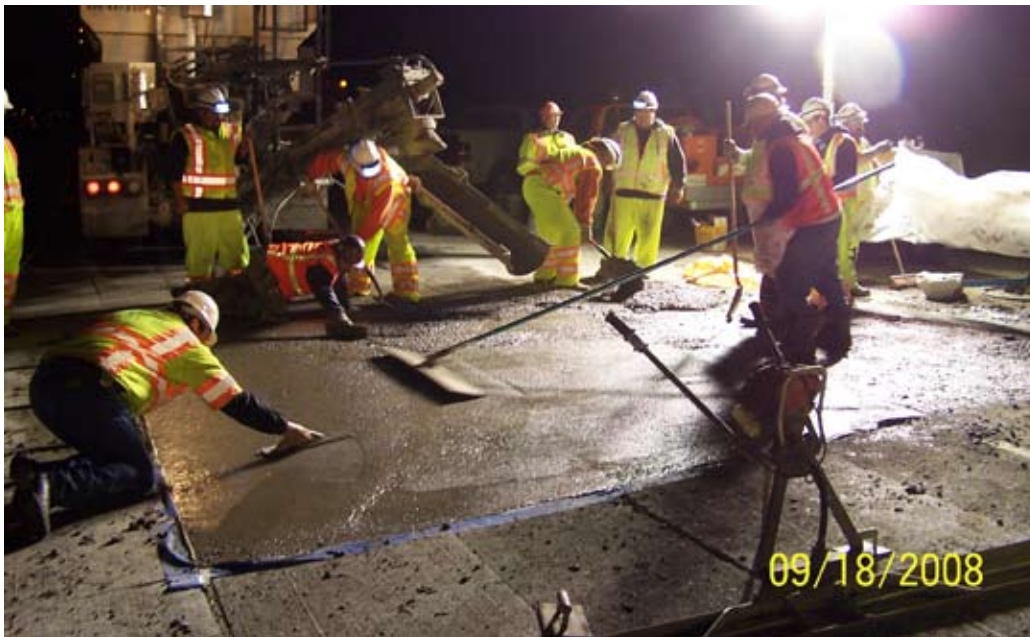
With everything and everyone in place, we began placing material at around 1:45 AM. It took a few minutes to get the slump dialed in, but generally placed between 4" to 6". The finishers were to use a vibrating power screed (truss type). The power screed they brought was too short to effectively use and ended up hand screeding instead.

A backpack mounted vibrator was on hand to consolidate and help move the material. After 18 minutes and several reminders, the first bull float went on the material. By 2:15 AM, material discharge was completed. The material had skinned by the time the tining rake was applied at the section first placed, thus it was difficult to achieve proper depth.

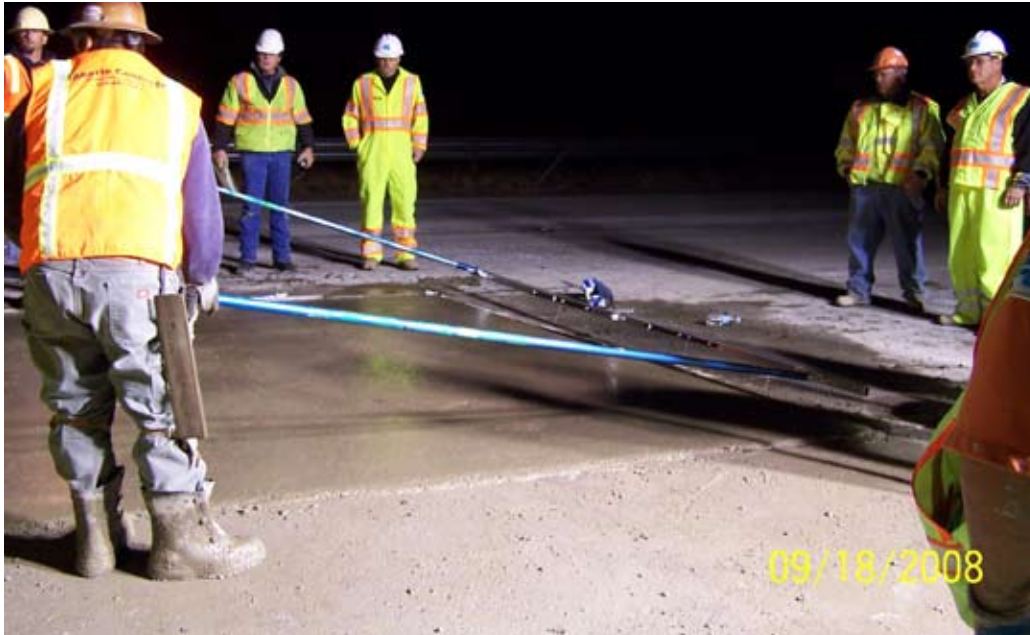
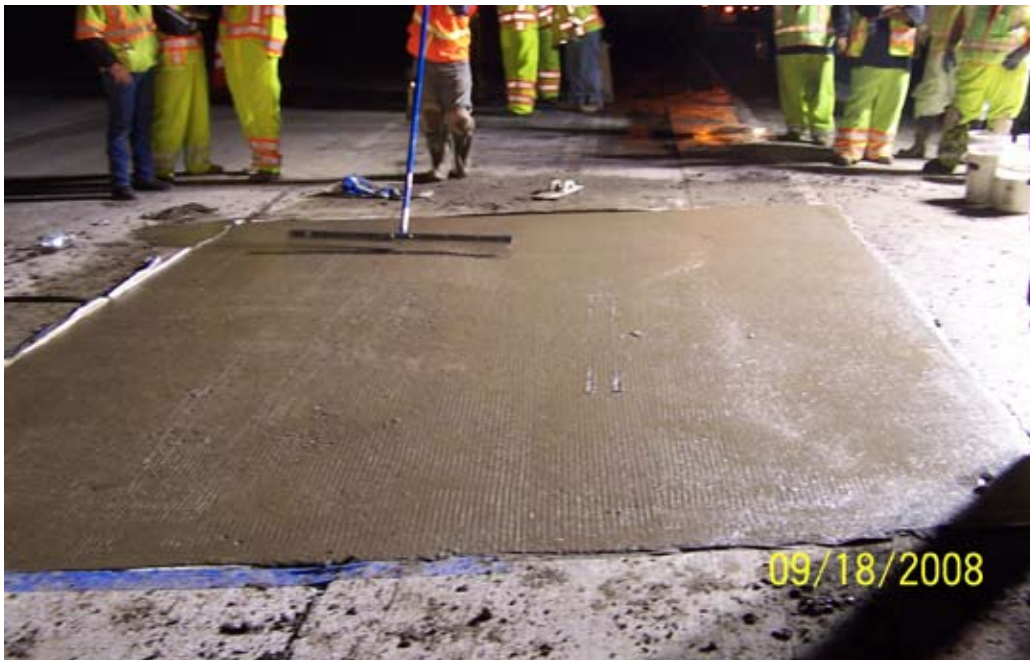
CALTRANS was advised that the lane could reopen at 4:30 AM, however, the repaired lane was not re-opened until approximately 6:00 AM.

CERATECH's **GreatWhite**® rapid cement performed as promised. CALTRANS officials were impressed and judged the surface texture acceptable and understood that with training, finishing would improve. Working with rapid sets, in general, require a mixer with a high production rate and a 12" auger would have definitely helped buy the finishers some time.
